Manhole Inspection Summary

Manhole # **S27C__094MH**

Insp Date: **5/13/09 11:37 AM**

Location Address: **800 MURPHY LN**

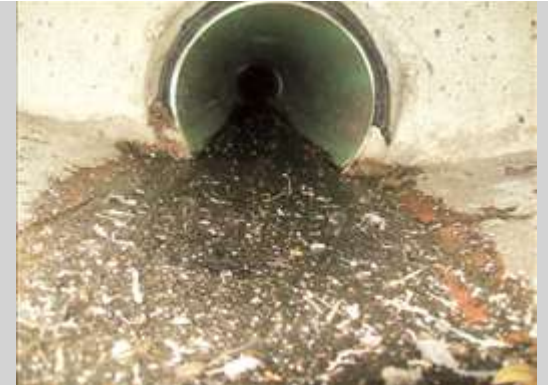
12 O'Clock Outflow

8 in. Circular Gravity Sewer
Pipe Out @ 12 O'Clock

Pipe Material: **PVC** ☐ Pipe Lined

Deposits: ☒ None ☐ Mud ☐ Sludge ☐ Debris ☐ Grease

Infiltration: **None** Pipe Seal Cond: **Sound**
